FIFTH QUARTERLY PROGRESS REPORT
EVALUATION OF HIGH-STRENGTH LIGHTWEIGHT
LAMINATED PRESSURE VESSELS OF
LAP-JOINT CONSTRUCTION

10 April 1963

Period covered: 1 January to 31 March 1963
Republic Aviation Corporation
Farmingdale, L. I., N. Y.

TECHNICAL REPORT NO. WAL TR 766.2/3-4

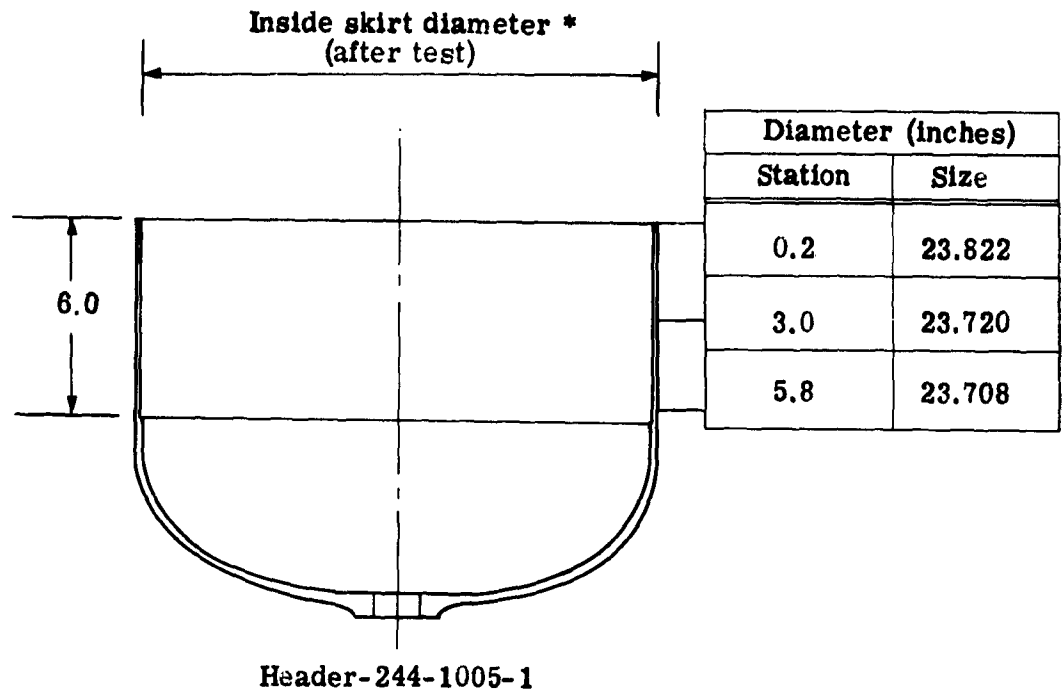
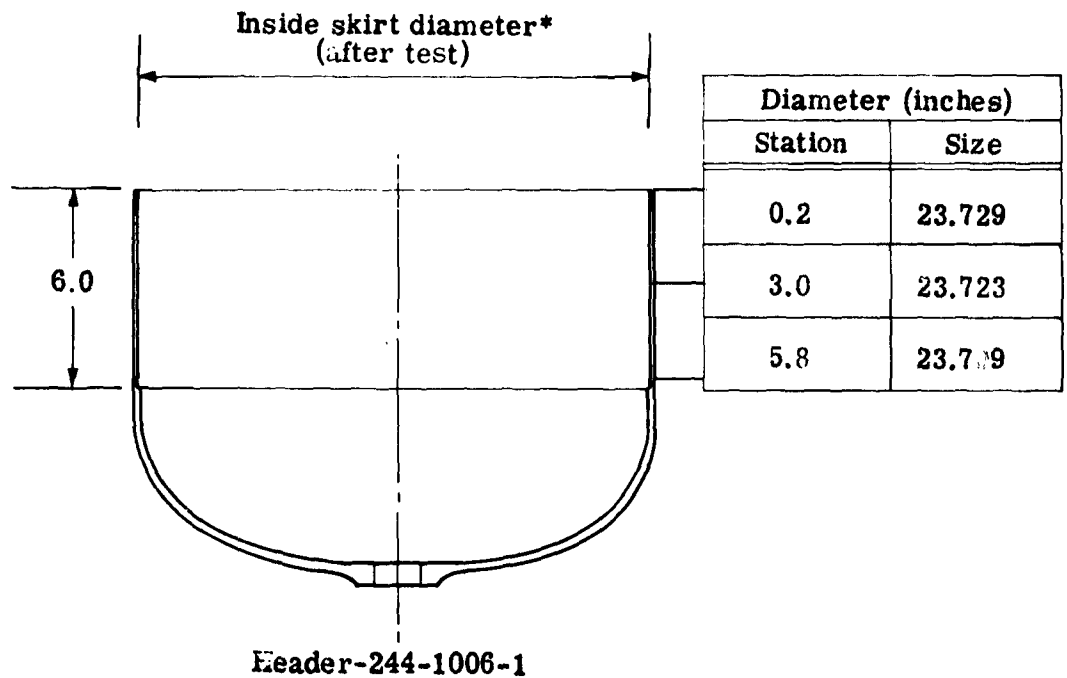
Figure 18. Inside Skirt Diameter of Headers after Use in Test Number 1 (III-101)

Vessel 2 (III-102) was fabricated using headers 244-1005-1 and 244-1006-1 (see Figures 16 and 17), FM47 adhesive, and three 0.021-inch-thick rings. These headers had been used in the III-101 assembly, and they had sustained permanent deformation. Figure 18 shows the dimensions of the headers before and after the test of assembly III-101. Header 244-1005-1 had been used in pressure vessel tests before this contract. The yield strength of this header was lower than the

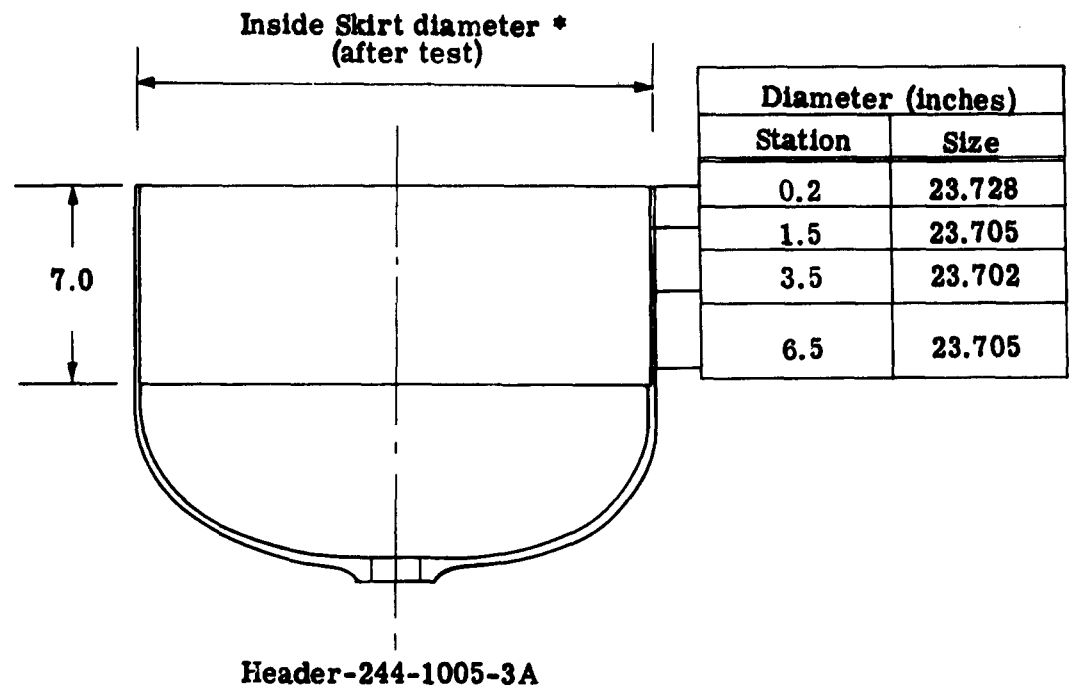
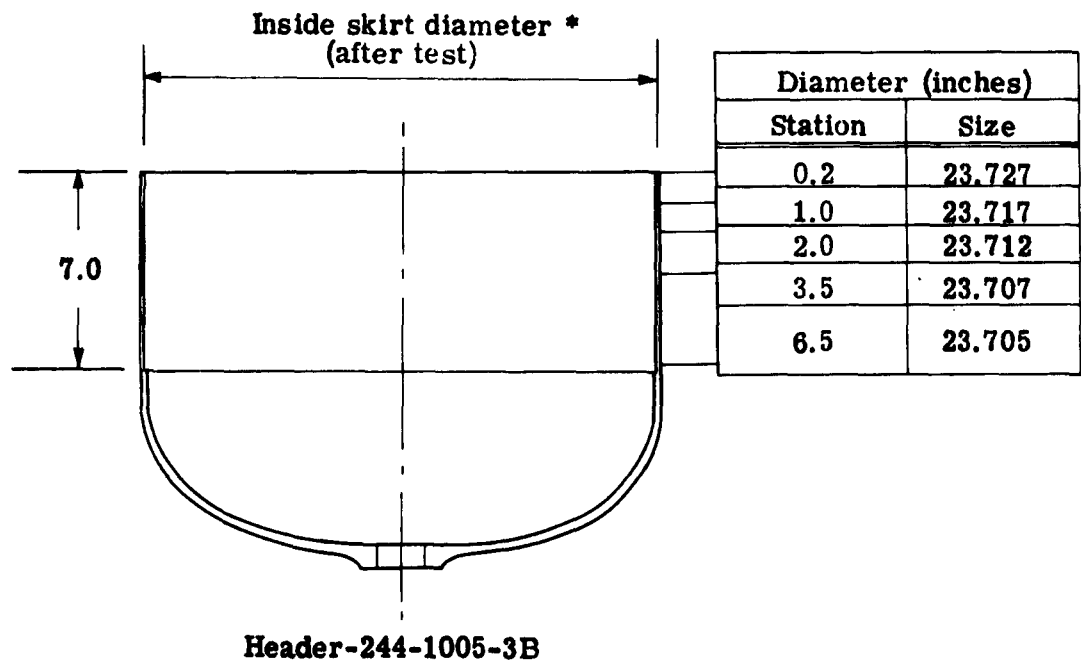
Figure 25. Inside Skirt Diameter of Headers after Use in Test Number 4 (V-201)

Pressure-vessel assembly 5 (V-202) was manufactured to the same configuration as assembly V-201 with one exception, which was necessitated by the permanent set sustained by the headers. Dimensional changes were made in the skirt portion of the headers because of the very high burst level of vessel V-201; these changes are shown in Figure 25. It can be seen that the magnitude of these changes is less than 0.1 percent of the permanent deformation except at the very edge where the tapered skirt is thinner to reduce the discontinuity effects in the mar-aging steel rings because of the increased thickness of the work-horse-design reusable headers. Because of the permanent set, extra layers of adhesive were used between the header skirt and the mar-aging steel inner-ring faying surfaces during the assembly process. When the assembly was tested, it failed at an internal pressure of 1520 psi. The failure originated in the weldment of the central inner ring at a membrane hoop stress level of 240,000 psi in the metal ring sections. To date, no uniaxial tensile tests have been performed on weldments in this gage of material, but data from tests on the 0.021- and 0.062-inch-thick welded specimens range from 243,000 psi to 265,000 psi (see "Fourth Quarterly Progress Report," Table 2, page 7). The average uniaxial strength of the parent material is 284,600 psi (see Table 6). Visual, X-ray, and stereomicroscopic examination of the weld
